Investigation on changes in gamma prime precipitate on varying surface locations of IN738 engine turbine blade

M. S. Hamizol¹, P. S. M. Megat-Yusoff^{1, a}, M. A. Nasrudin¹, M. A. Meor Said¹, M. S. Jasmani² and S.M.A. Syed Ahmad Ghazali³

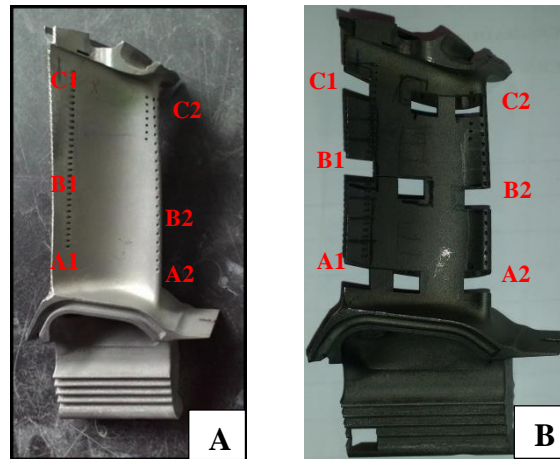
Figure 1. Turbine blade sample at different points (A) Before machining; (B) After machining.

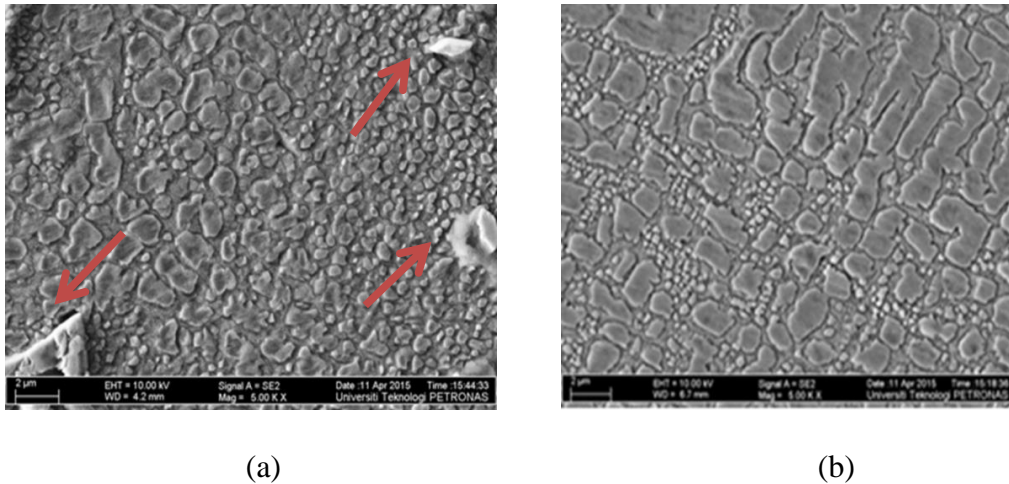
Each specimen from both the pressure side and the suction surface side locations had been examined by using SEM and comparison was made accordingly. Figure 2(a) illustrates the microstructure or the morphology observed at location A1. At this location, (γ^I) precipitates were observed as it was exposed to constant thermal and stress during the blade operation. The micrograph reveals over aging as the secondary structure of precipitates had been induced by these operating factors. The precipitates were nearly cubical, while some were spheroidal in shape. In fact, a similar conclusion was reported by [2], whereby the formation of grain boundary was mainly carbides. Other than that, the secondary spheroidal (γ^I) precipitates had been observed to vary in size and shape, which might be a result of exposure of the suction surface side to intense heat as the temperature rose. The grains boundary formation was intermittent. Furthermore, most of the secondary (γ^I) precipitates displayed a globular structure although some became coarser; resulting in a rougher edge or perimeter. This might be due to the prevailing elements, which is in agreement with a study by [15] that reported the dependency of (γ^I) precipitate phase in volume fraction upon Al or Ti contents. On top of that, a stone like structure can be observed at location A1, as highlighted by the arrows. These are the MC type carbides of seed like or stone structure that occur within the grain boundary, also as depicted in the literature [4, 15]. However, the structural shape of the MC carbides varied at various points on the surface. Similar results of these MC type carbides for IN738 turbine blade had been reported at different stages of the blade [6]. The MC carbides that had been observed were in the form of white structure due to the use of backscattered electron imaging (BEI) during SEM process. These precipitates could cause a reduction in the stress-rupture life, ductility, and micro hardness[10]. Besides, Figure 2(b) portrays the population of gamma prime (γ^I) precipitates in a vivid manner due to their bigger size and formation of joined structure compared to the population of gamma prime (γ^I) precipitates at location A1. In fact, bigger-sized secondary (γ^I) precipitates were observed at Location A1. Additionally, the distribution of the precipitates had been bimodal, in which the fine and primary (γ^I) precipitates were combined with huge-sized secondary (γ^I).

Figure 2. (a) The microstructure at location A1; (b) The microstructure on location B2.

Moreover, the huge secondary (γ^I) precipitates were no longer in the form of globular and spheroidal. In fact, some of these secondary precipitates enjoined and formed elongated structures with rough edges. The primary gamma prime precipitates were dominant and well-formed; unlike the secondary gamma prime precipitates, as observed in the SEM imaging. Nevertheless, although discontinuous, these findings are in consonant with a study by [10], where the primary (cubical) (γ^I) were formed at the expense of the secondary (spheroidal) (γ^I) structure. Moreover, the formation of MC carbides had been more compared to that at location A1. Furthermore, the SEM micrograph at location C1, as shown in Figure 4, exhibits unexpected microstructure with defects. The defects or voids are reflected as dark spots in the microstructure. Hence, non-smooth surface was obtained for the turbine blade with the absence of (γ^I) population, which can cause potential environmental hazard due to the exposed surface. A similar observation reported by [9] on vicinity crack surface of IN738 showed that the population of (γ^I) precipitates disappeared along the crack paths.

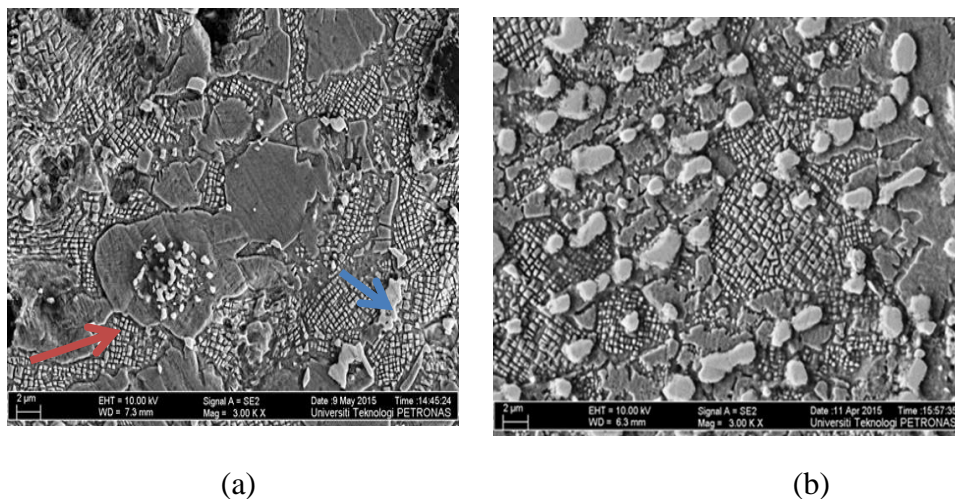
Figure 3 (a) Microstructure on location C1; (b) Microstructure on location C2.

Figure 3(a) demonstrates two types of carbides formed at point C1. The formation of $M_{23}C_6$ was in the form of aligned carbide along the grain boundaries (bottom right of Figure 3(a)). Thus, the formation of $M_{23}C_6$ refers to the polycrystalline structure of the

material due to the existence of grain boundaries. However, the MC type carbides were smaller in size and randomly distributed without any specific orientation, as found in $M_{23}C_6$. In addition, MC carbides existed within grain boundaries; unlike $M_{23}C_6$ [10]. Further observation of the microstructure revealed similar bimodal distribution of the (γ^I) precipitates. However, fine primary cuboidal (γ^I) precipitates developed into coarser and distinct cubical, as well as rectangular in shape. Meanwhile, the larger secondary (γ^I) precipitates evolved into bigger size than that observed at Locations A1 and B2. Meanwhile, the microstructure for location C1, as illustrated in Figure 3(b), displays the prominent existence of $M_{23}C_6$. $M_{23}C_6$ carbides were well organized in vertical and horizontal lines, which further indicates that the grain boundaries had been well oriented. However, the arrangement of $M_{23}C_6$ carbides started to distort due to a change in the arrangements of (γ^I) precipitates. As a matter of fact, this also indicates changes in the grain boundary. The background structure, nonetheless, still remained as bimodal (γ^I) precipitates. Meanwhile, the structure of secondary (γ^I) precipitates began to disappear and were replaced with primary (fine) (γ^I) precipitates. Hence, the distribution and the population of primary (γ^I) precipitates turned dominant. In fact, the structures of the primary (γ^I) precipitates developed into distinct cubical structure, as shown on Figure 3(b).

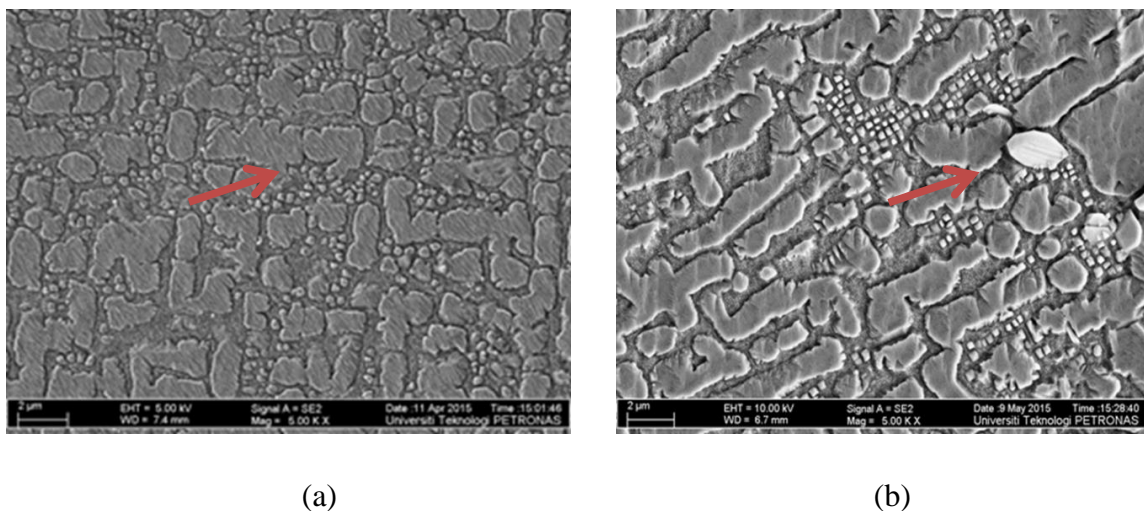
Figure 4 (a) Microstructure locations B1; (b) Microstructure at location A2.

In addition, Figure 4(a) presents the microstructure for location B1. The cell-like sub-grain sizes reduced at the pressure surface side, as depicted in Figure 4(a) B1; unlike the suction surface side sample specimen A2, which could be due to the coarsened sigma (hardened) phase before shifting to equilibrium phase. More so, the low-density dislocation of the cell-like sub-grain projected discrete development. The formation of bimodal (γ^I) structure at this location demonstrated coarsening of the precipitates. The secondary (γ^I) precipitates appeared less cubical, but instead, had rough edges. Similarly, the primary (γ^I) precipitates were also less cubical in shape, but appeared to be more spherical. In terms of carbides formation, both types of carbides, $M_{23}C_6$ and MC, were successfully detected (not shown) although reduced in population. Finally, the microstructure observation on the middle, lower part of the turbine blade, which is Location A2, is depicted in Figure 4(b). The microstructure showed larger secondary

spheroidal (γ^1) precipitates compared to that for location B1. The population was also higher at location C2. The bimodal structure, nevertheless, still remained similar with that of other locations, except Location A. Moreover, coarsening of both secondary and primary (γ^1) precipitates were observed compared to that in location B1. The structure of the secondary (γ^1) precipitates showed rough edges, while the primary (γ^1) precipitates had distinct cubical structure. In addition, the MC type carbides were also present in the microstructure, as indicated with the arrow. The diffusion-less transformation along the grain boundary was not unclearly detected in the SEM image in Figure 4(a), however, progression of recovery towards grain interior was observed after operation hours and exposure to high temperature. In addition, isolated and discrete carbides had been obvious along the grain boundary. The proportional effects of the growth of these grains with time, unfortunately, remains unpredictable.
