SURFACE FINISH WHEN THREADING TITANIUM-BASED ALLOY UNDER DRY MACHINING

Siti Hartini Hamdan, Ahmad Yasir Md Said and John Rizal Biki

Faculty of Mechanical and Manufacturing,
University Kuala Lumpur Malaysia France Institute,
43650 Bandar Baru Bangi, Selangor, MALAYSIA.
E-mail: sitihartini@mfi.unikl.edu.my, yasir@mfi.unikl.edu.my

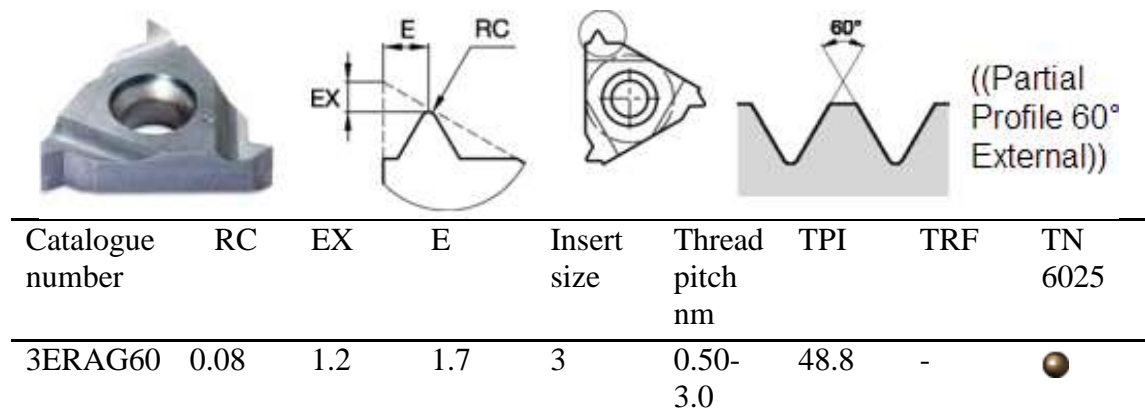
Figure 2. Cutting tool geometry specification.

Titanium alloys are available in several different grades. Most of the grades are of alloyed type with various additions of, for example, aluminium, vanadium, nickel, ruthenium, molybdenum, chromium or zirconium. Titanium alloy Ti-6Al-4V is a widely used grade as it offers high strength, depth hardening ability and elevated temperature properties up to 400°C. The workpiece material used in the thread machining was a titanium alloy Ti-6Al-4V, the composition of which is given in Table 2. A rod with ϕ 38mm was cut using a band saw to a length of 140mm. The rod was turned to ϕ 22mm and faced to 120 mm length by using a conventional lathe machine. The thread was then produced under dry machining based on the required cutting parameters. The material was then to be divided into smaller portions, as illustrated in Figure 1. Carbide coated with PVD aluminium titanium nitride (AlTiN) was used as the threading insert. The thread dimensions were M22 x 2.0 sharp 60° V (see Figure 2).

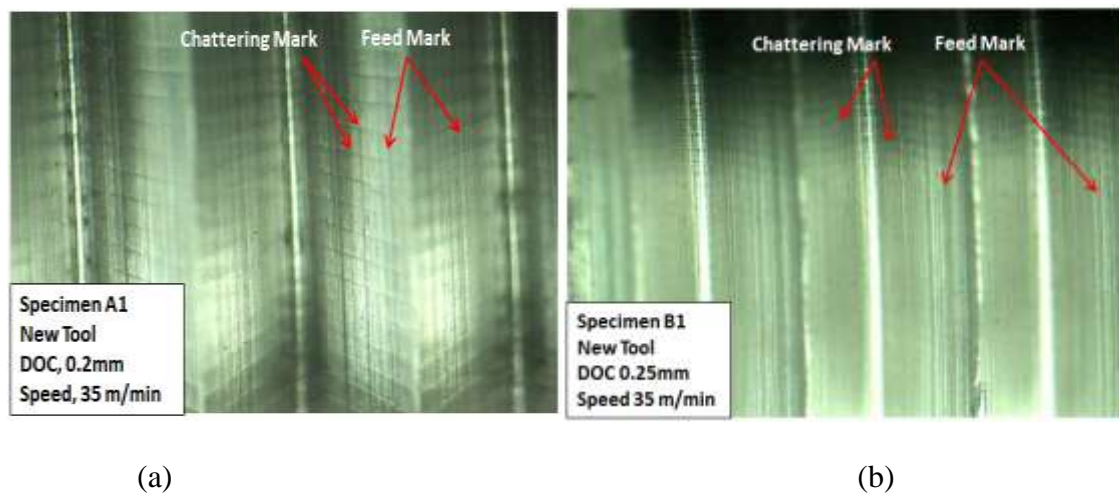
Figure 3. (a) Chattering mark and feed mark clearly visible-50x; (b) Feed mark clearly visible and chattering mark gradually disappearing -50x.

The variation in surface texture for each specimen can be seen via optical microscope. From the experiments, two types of surface pattern were identified, consisting of feed marks and chattering marks. The phenomenon known as “chatter” happened during the cutting operation, where several types of vibrations influence the chip flow-rate and final work surface. Compared to free and forced vibrations, self-excited vibrations are more detrimental to the finished surfaces and cutting tools and this may result in large amplitudes of relative motion between the cutter and workpiece [22]. The feed mark reflects the depth of cut on the thread, where a greater depth of cut produced a rougher feed mark. A smoother thread surface can be obtained by providing 0.5mm or less depth of cut for the finishing cut. The chattering mark was caused by the workpiece’s clamping position during the cutting process. The greater the distance from the clamping point, the clearer the chattering mark produced on the specimen as the workpiece tends to chatter. Figure 1 shows the workpiece’s clamping position during the studied specimen production. The chattering marks gradually disappear when the specimen gets closer to the clamping point.

No critical surface damage was found on specimens produced by the new tool, as can be seen in Figure 3 and Figure 4. Only slight differences can be visually spotted between specimens A1, B1, C1 and D1 which were respectively produced by the new tool. In general, the surface roughness of the machined component decreased with the increase in cutting speed [21]. This proves that the variable cutting parameters that were set to generate variation in the thread surface texture were not effectively achieved. Greater differences in the range of depth of cut and cutting speed should be set for better results. A feed mark appeared to be relatively clear on each specimen as it approached the clamping point. A chattering mark was clearly visible on specimen A1. However, it gradually disappeared on specimen C1. The surface finish tends to become smoother towards the end of tool life. This is probably due to deformation on the flank face or adherence of the workpiece material at the tool nose [20]. The visuals were focused randomly on the roots of the thread and no other damage pattern was found.

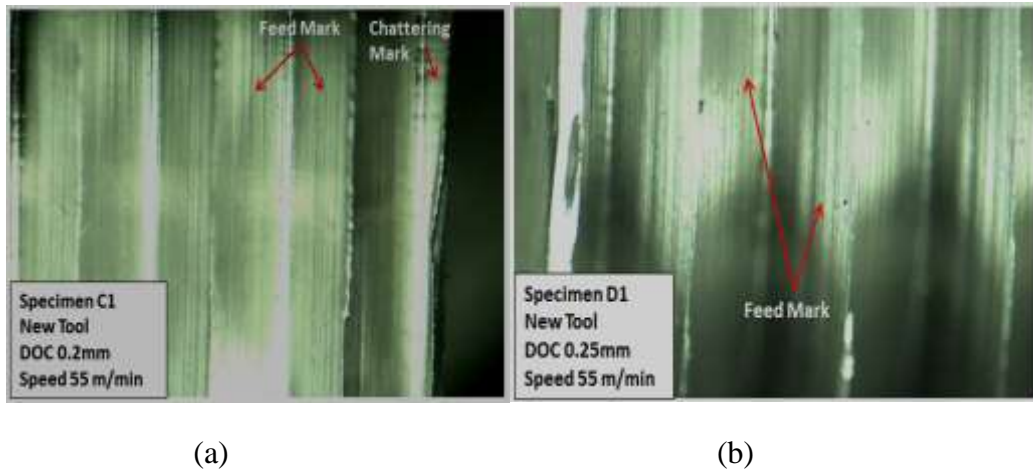
Figure 4.(a) Chattering mark prone to disappear but feed mark clearly visible -50x
 (b) Chattering mark totally disappears but feed mark clearly visible- 50x.

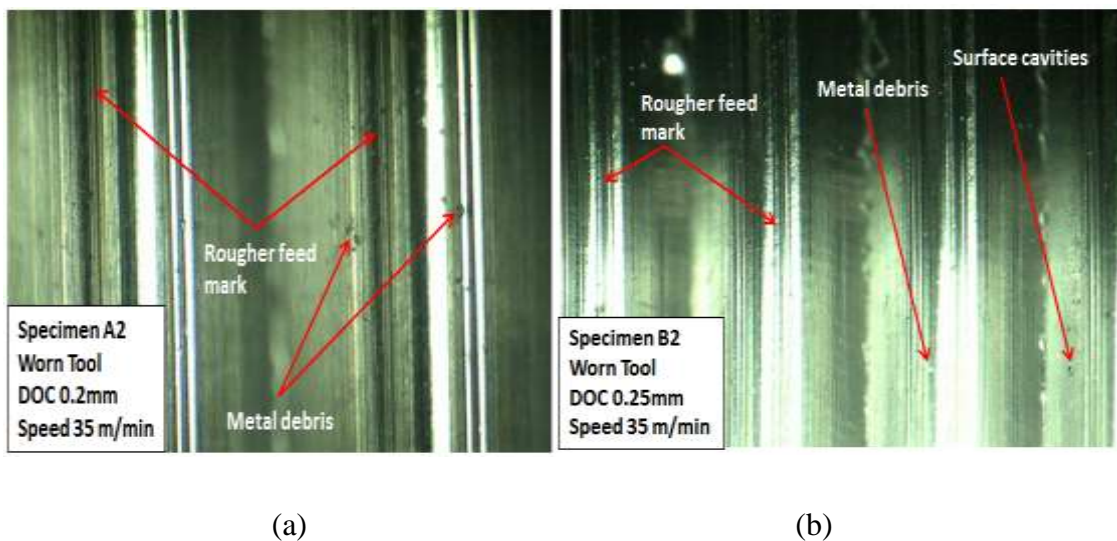
Figure 5. (a) Surface damage produced by worn tool - 50x; (b) The existence of surface cavities and other damage - 50x.

Visual optical observation on specimens produced by the worn tool revealed several types of surface texture damage, as shown in Figure 5 and Figure 6. Machining of the titanium alloy with the nearly worn tools tends to increase the hardening rate of the surface layer [20]. Other than a rougher feed mark, damage in the form of metal debris, surface cavities and a cracking boundary was also spotted. The assumption is that the worn tool was not cutting effectively, but tends to rub the material surface, especially for a difficult-to-machine material like titanium alloy. When the cutting tool became dull, this meant that the nose radius became bigger, and the change in the nose radius corresponds to the feed marks on the machined surface [7]. The rubbing action provides high cutting pressure which causes the workpiece to tend to move away from the cutting tool. In addition, a freshly cut surface may be burnished by a dull cutting tool, and hence work-hardened at the machined surface [23]. Furthermore, extreme undissipated heat generated at the cutting edge encourages the accumulation of sheet-material on the tool surface. This process is usually known as galling and is related to adhesion wear. This condition is part of a factor that contributes to the abovementioned surface damage.

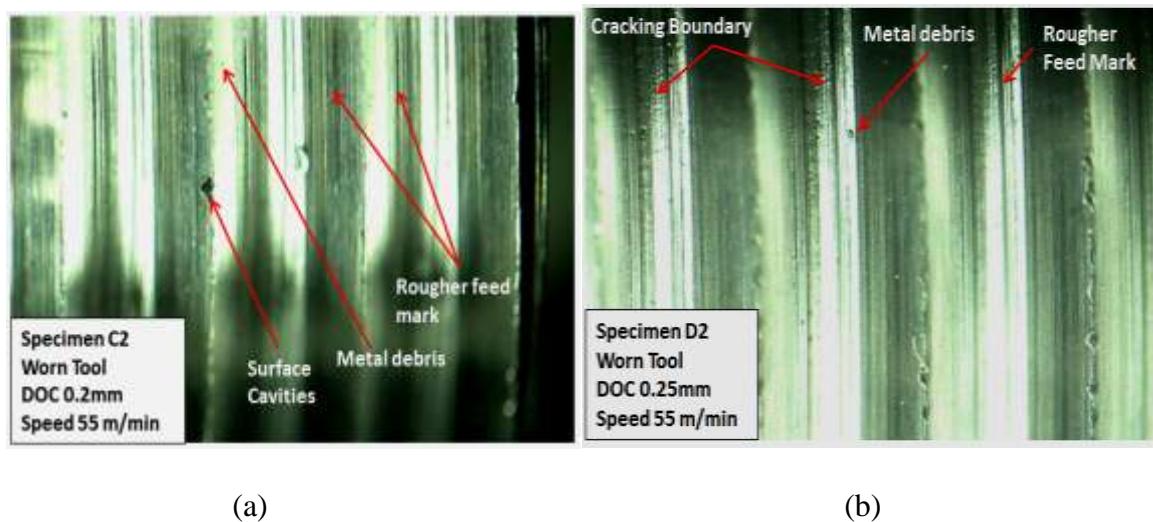
Figure 6. (a) Larger surface cavities and other damage spotted- 50x; (b) Cracking boundary and other damages spotted-50x.
