Thermal phenomenon of glass fibre composite under tensile static and fatigue loading

The aim of this study is to understand the thermal phenomenon of unidirectional Glass Fibre Reinforced Polymer (GFRP) composite under static and fatigue (tensile) loads. This study used a rectangular shaped GFRP composite and consisted of specimens with and without a circular notch. Under static test, the constant displacement rate was applied. Under fatigue test, frequency and amplitude of stress were explored to study the fatigue properties and damage evolution of the specimen. Thermography was used in real-time observation to obtain the temperature profile on the external surface of the specimens. This experimental method showed that the thermal phenomenon gave a good detection of the damage appearance of GFRP material under static loading. Moreover, thermal phenomenon gave a good correlation with the energy dissipation under fatigue loading. Thermal phenomenon successfully determined the high cycle fatigue strength of GFRP composite. This study concluded that thermal phenomenon observed by Infra-Red (IR) camera has successfully demonstrated the damage propagation and the strength behaviour of

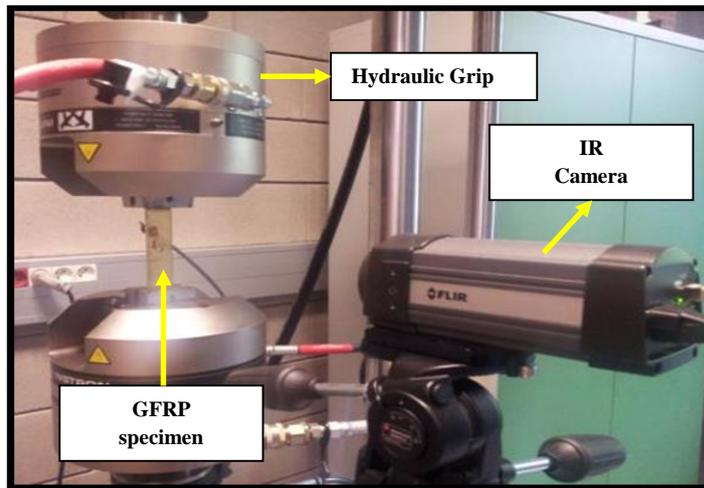
Figure 2. Experimental set up.

This experiment was divided into two stages. Tensile static testing on GFRP composite without hole and observed with IR camera. Tensile fatigue testing on GFRP composite with hole and observed with IR camera. Test was carried out with a servo-hydraulic testing machine, the INSTRON Machine 8501 with a capacity of 100 kN. The machine was equipped with a standard load cell and mechanical grips. The global longitudinal strain of the specimen was measured based on the crosshead displacement and the local longitudinal strain was measured using an electric uni-axial strain gauge with a gauge length of 5 mm attached to a specific position of the specimen surface. Static tensile tests were performed under a constant cross-head speed of 1 mm/min. Fatigue tests were performed under load control and at a stress ratio, R , equal to 0.1, i.e., tension loading and constant 3 Hz of frequency (ASTM D 3479). Various maximum stresses were used for the fatigue tests. The test specimens were allowed to cycle until failure occurred or until a predetermined number of cycles was reached. Moreover, rapid test of fatigue loading with same parameters was also conducted to determine the high cycle fatigue strength and fatigue life utilising IR camera that referred to the Risitano's method. This rapid fatigue test used one specimen for each test of maximum stress until reaching 10000 cycles. Once the 10000 cycles were reached, the test was stopped, then continued with the next maximum stress. In following the temperature changes on the specimen surface, an Infra-Red camera of FLIR A325sc was used for the tests. Control of the camera and data recording were done with the FLIR R&D software. The FLIR R&D software was able to measure temperature change in various shapes and dimensions such as spots, lines, and area as well as when using various palettes of colours and shades. The camera resolution was 320 x 240 pixels with a detector type of uncooled microbolometer. Camera spectral range was 7.5 to 13 μm , whereas the temperature range was from -20°C to $+120^{\circ}\text{C}$ with $\pm 2^{\circ}\text{C}$ or $\pm 2\%$ accuracy of reading. The camera was provided with the automatic correction of emissivity and atmospheric transmission based on distance, atmospheric and relative humidity. IR camera was placed approximately 30 cm of fix distance in front of the specimen surface; therefore, it was possible to obtain full-field thermal maps of the specimens during the tests. This thermography observation did not use an external heat source. In this case, the thermal images acquisition were set at 30 Hz. Figure 2 shows the experimental set up.

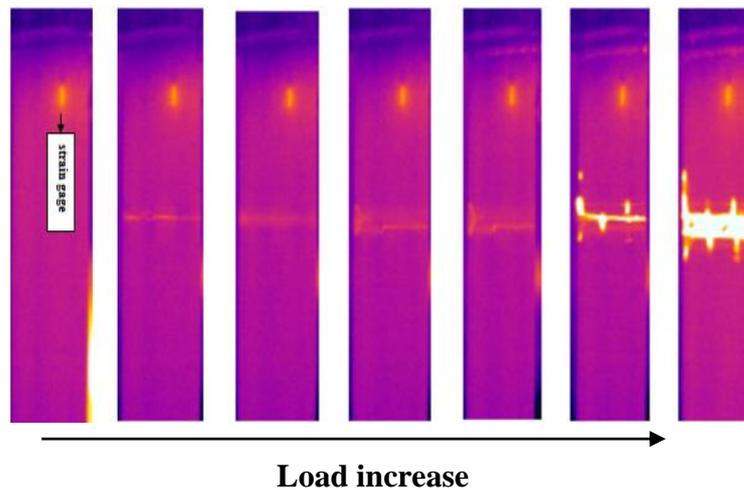
Figure 3. Thermal images of GFRP composite without hole.

During the test, specimen surface was also observed by the IR camera to follow the evolution of temperature. Figure 3 shows the thermal images up to the final failure. In order to follow the evolution of temperature during the test, the area profile was used at several areas of specimen surface to study all changes of the maximum temperature until the final failure, as seen in Figure 4.

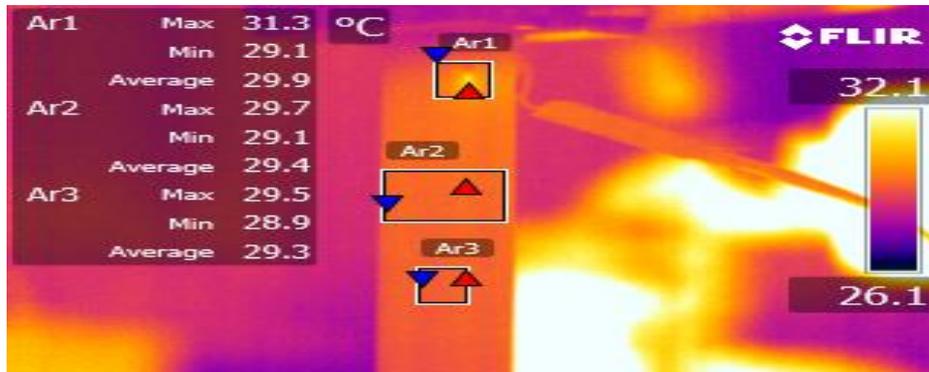
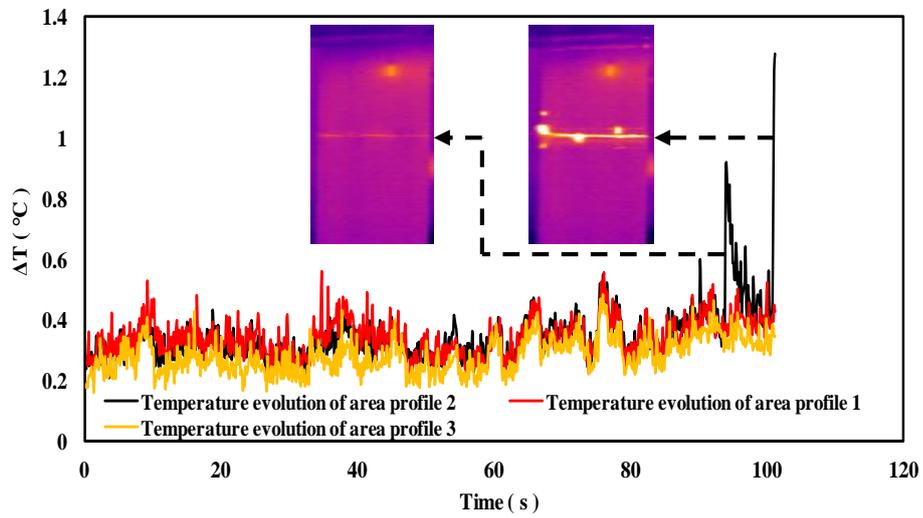
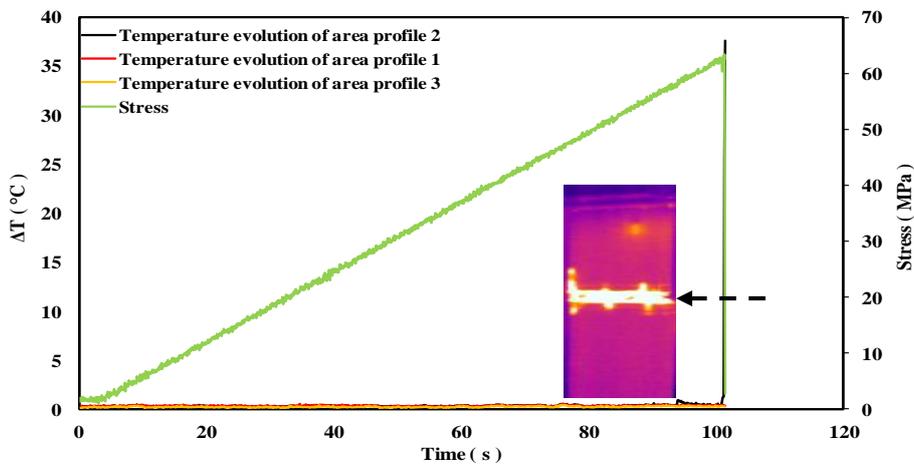
a) Temperature image observation / profile area

b) Before final failure

c) Until final failure

Figure 4. Temperature evolution of GFRP composite without hole.

From Figure 4 above, all the temperature surfaces (ΔT) detected by the IR camera varied between $0.2 - 1.3$ °C. From the comparison between thermal images and temperature change during the test before the final failure, ΔT above 0.6 °C was clearly shown by several peaks of temperature profile related to the presence of macro damage. When damage occurred, it represented the energy which was gradually released. The energy that has been absorbed was sufficient to create macro-cracks, enlarging the pre-existent ones, and also to create new inner and surface cracks. The heat generated from

Each of the peak of temperature indicated different types of initial macro damage. We found that $\Delta T \approx 0.9 \text{ }^\circ\text{C}$ was directly associated with the appearance of macro matrix cracking and $\Delta T \approx 1.3 \text{ }^\circ\text{C}$ was related with the appearance of interfacial failure or splitting. The higher temperature of splitting was in fact due to absorbing more energy of damage [48]. From the temperature evolution during the tensile test, the presence of macro damage indicated the area of final failure which was concentrated in the region of the failure area. In sum, the initial macro damage provoked the occurrence of catastrophic or final failure of the specimen that induced the highest peak of temperature at $\Delta T \approx 37 \text{ }^\circ\text{C}$.

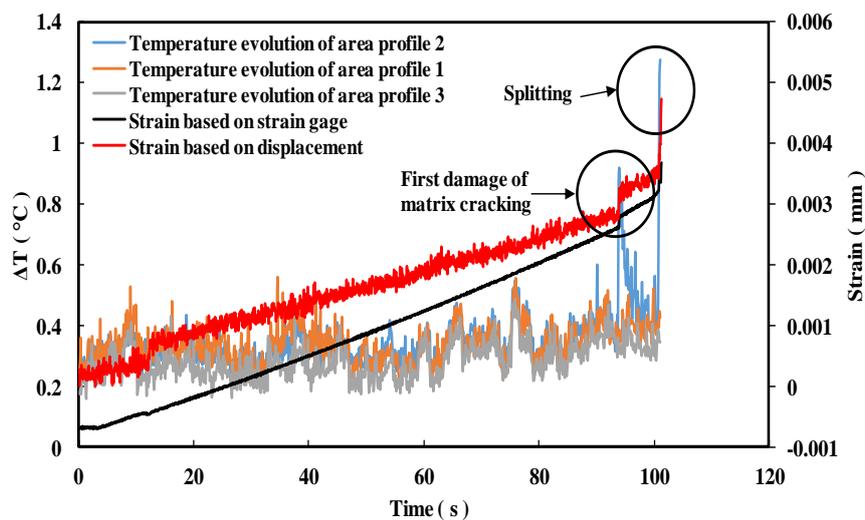
Figure 5. Strain and temperature evolution of GFRP composite without hole

Using the information of strain propagation that occurred when this initial macro damage occurred, thermography and strain gage confirmed the presence of initial macro damage which happened before the catastrophic or final failure of the specimen as seen in Figure 5. The damage appearances were shown with a small discontinuity in the strain curve and also higher increase of temperature at the same time. It can be noted that the combination of this experimental method of thermography observation by IR camera and strain propagation by strain gage under static tensile loading can give good local information and excellent correlation with local strain from the strain gage about the early damage appearance and propagation, as well as damage type and damage location until a rupture based on the temperature profile and strain value of GFRP composite [42].

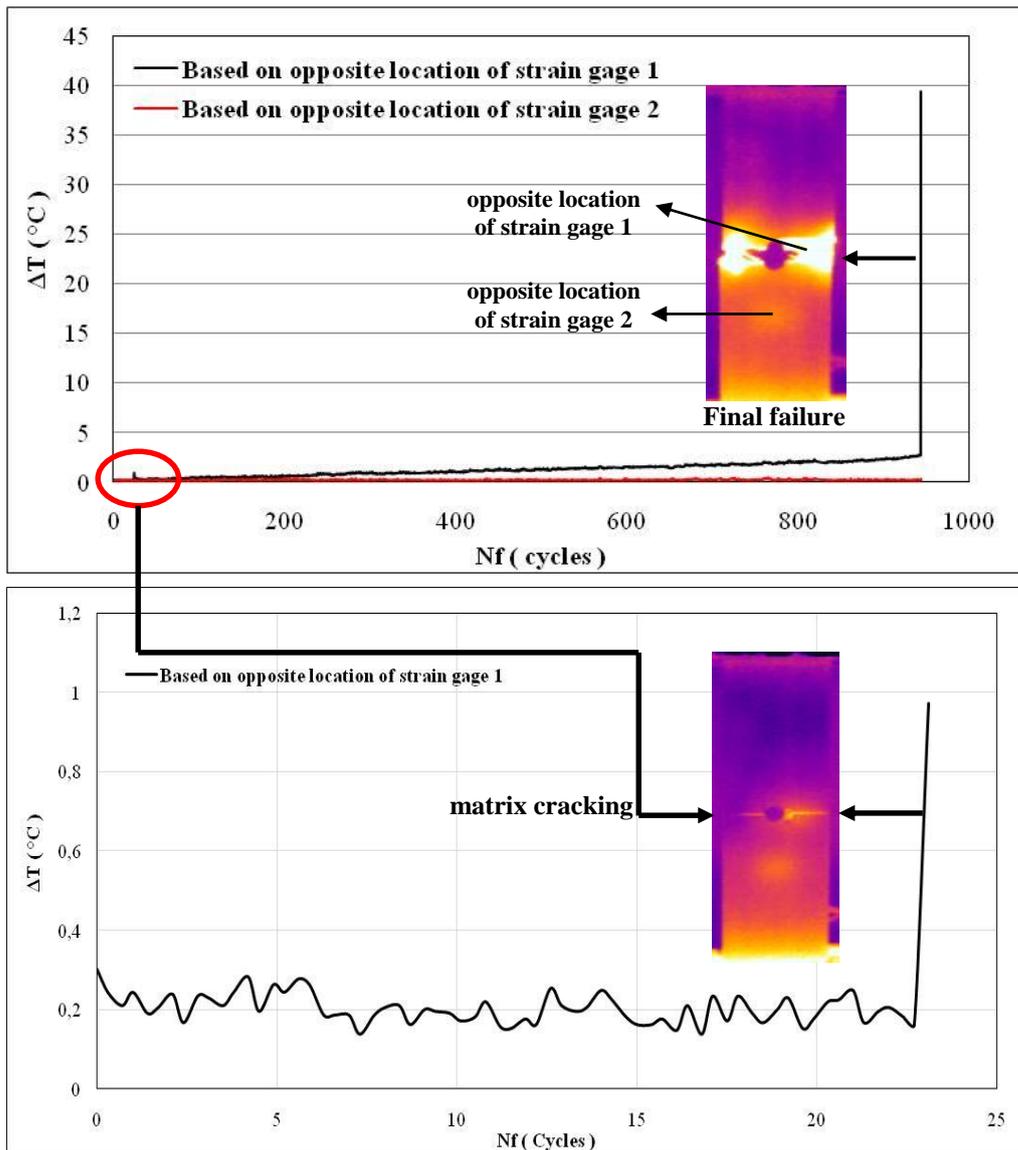
Figure 6. Evolution of surface temperature of GFRP composite.

During the fatigue tests, IR camera was used to follow the temperature changes on the specimen surface. Figure 6 represents the temperature changes at the edge of the hole during the fatigue test with 65% of UTS. From Figure 6, all the temperature surface (ΔT) detected by IR camera varied between $0.2 - 39 \text{ }^\circ\text{C}$. From the comparison between thermal images and temperature change during the test before the final failure, $\Delta T \approx 0.9 \text{ }^\circ\text{C}$ which was clearly shown by the peak of temperature profile related to the presence of the first macro damage of matrix cracking. After that, the temperature was shown to reach a stable period of the increase trend [37]. The temperature profile had a gradual increase trend with the slope $\approx 0.001 \text{ }^\circ\text{C}/\text{cycle}$ until around 200 cycles and continued to increase with a slightly higher slope $\approx 0.002 \text{ }^\circ\text{C}/\text{cycle}$. The temperature increased until around 800 cycles. The trend of temperature experienced a significant increase at the final period.

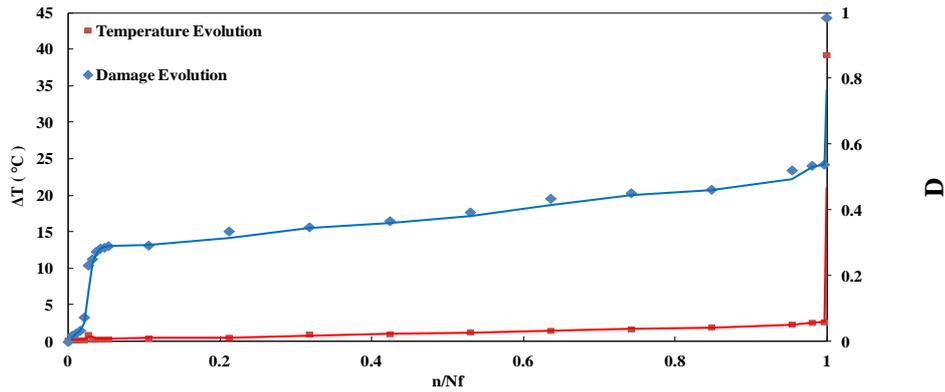
Figure 7. Temperature and damage evolution of GFRP composite with 60% of UTS.

With three times of higher slope, at $0.006\text{ }^{\circ}\text{C}/\text{cycle}$ until reaching the rupture, ΔT suddenly increased and reached the highest $\Delta T \approx 39\text{ }^{\circ}\text{C}$ at one cycle. The temperature evolution was then compared with the damage evolution as seen in Figure 7. From the temperature and damage evolution during the tensile fatigue test (Figure 6 and Figure 7), the presence of damage was indicated by temperature change on the specimen surface during the test that existed and concentrated at the hole. Meanwhile, the temperature evolution at other areas of specimen surface that were far from the hole did not show an increase of temperature or relative to have the same temperature from the beginning of the test until the rupture of the specimen [47]. When damage occurred, it represented the energy which was gradually released. The heat generated from the energy release was then detected by the IR camera that showed an increase in temperature in the area of damage. The evolution of the temperature can be categorised in four stages. In the first part, the initial increase of temperature was possibly due to the micro cracking in matrix [47]. In the second part, a sudden increase in temperature was caused by the first

appearance of macro matrix cracking. After that, the temperature reached a slowly increasing trend due to the stable growth of matrix cracking as part of the third stage [47]. The final part, a significant increase trend of temperature could be due to fibre/matrix debonding as the interfacial failure in splitting the form and finally provoking the occurrence of fibre fracture which was dealing with the rupture of the specimen [47]. It can be noted that the combination of this experimental method of thermography observation by IR camera and strain propagation by strain gage can give a good confirmation with local strain from gage detection on the damage appearance and evolution of GFRP composite with holed specimen under tensile fatigue loading.

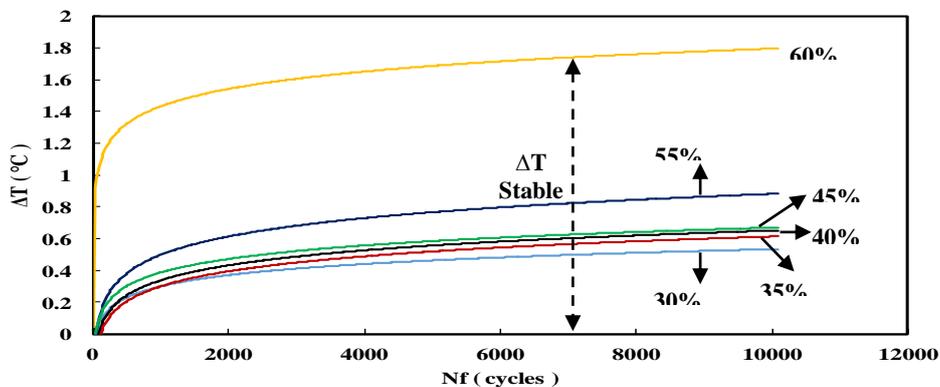
Figure 8. Temperature profile of GFRP composite for each load level.

The purpose of this analysis is to determine the fatigue strength based on experimental results by means of IR camera and energy dissipated in a unit volume of material. Thermographic approach that relies on the use of an IR camera, as originally called the Risitano method has shown to be useful for the determination of high cycle fatigue strength (HCFS) of composite material [34, 48, 49]. The main advantage of this method provides a rapid determination of HCFS that is a very efficient time-consuming procedure and provides substantial saving of fatigue test costs [49-51]. This test was conducted using GFRP composite with a holed specimen and under the loading frequency of 3Hz and $R = 0.1$. Using the IR camera, a temperature profile for specimen surface was used as a function of the number of cycles for a test with different load levels. The fatigue tests were conducted until 10000 cycles to have a stable or a plateau profile of temperature evolution as is seen in Figure 8.

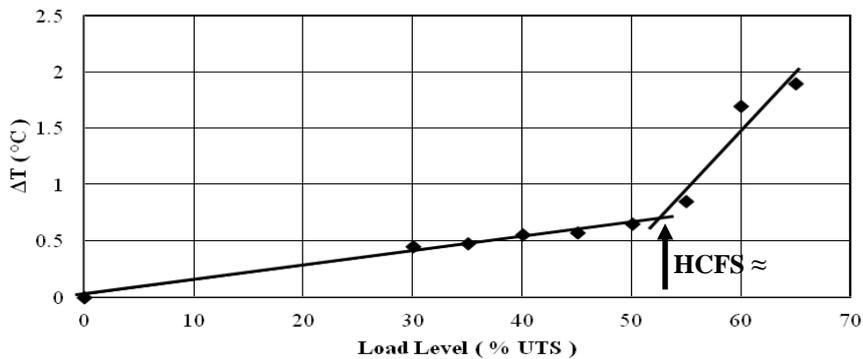
Figure 9. HCFS of GFRP composite by thermography method.

Figure 9 confirms the HCFS of 53 % of UTS, and it can be noted that HCFS was determined by the thermography approach successfully applied for the GFRP composite material. Furthermore, an investigation for a quantitative characterisation based on intrinsic energy dissipation was presented to validate the accuracy of the thermography approach. The energy dissipation was identified as the area enclosed by a hysteresis loop for a particular cycle according to the cycle in the ΔT_{stable} period, as illustrated in Figure 10(a). Next, a plot of energy dissipation per unit volume as a function of the load was created to determine HCFS as seen in Figure 10(b).

The HCFS of $\approx 48\%$ of UTS obtained by energy dissipation in Figure 10 was found to not differ significantly to that obtained using the thermography method in Figure 9. From the comparison result of HCFS based on thermography and HCFS based on energy dissipation, the thermography method showed good correlation of following the damage behaviour with the conventional approach, which is a key finding to study the damage behaviour of unidirectional GFRP composite. Furthermore, a plot in Figure 11 was established between energy dissipation per unit volume and ΔT_{stable} for each load level of fatigue test to obtain the relationship between thermal dissipated detected by IR camera and energy dissipated from the hysteresis heating. The relation between stabilisation temperature profile and the energy dissipation during fatigue test can be approximated by a linear function with a data correlation factor, R^2 close to 1. It can be said that the increasing of temperature detected by the IR camera on the specimen surface as a result of thermal dissipated was in fact due to energy dissipation of the material. The

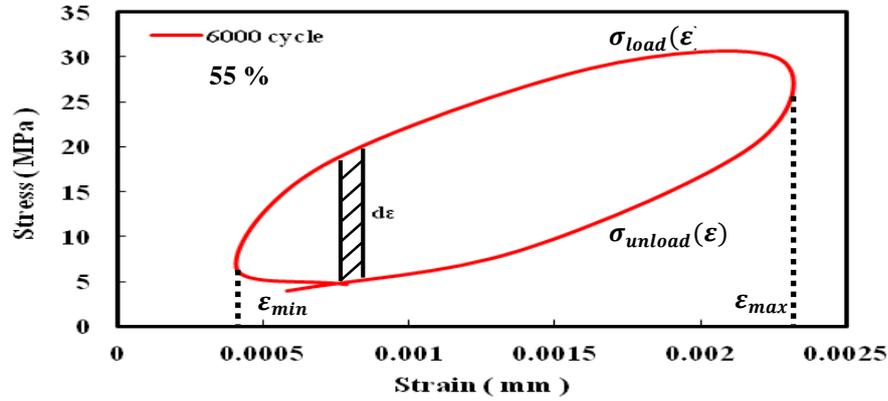
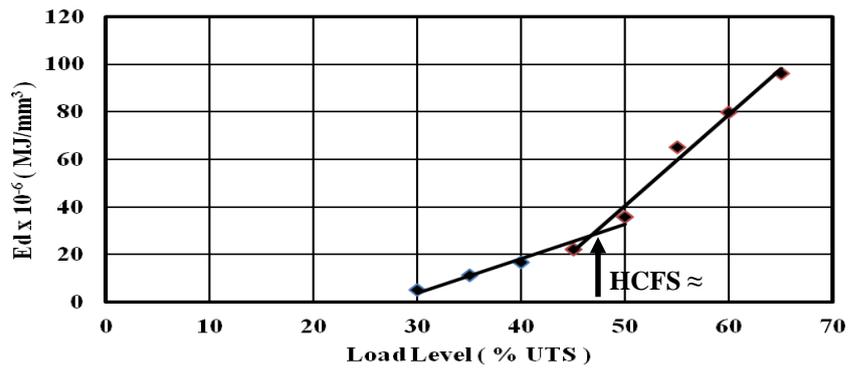
a. Hysteresis loop during 55% of UTS

b. Energy dissipation as a function of load level

Figure 10. Hysteresis loop and energy dissipation for GFRP composite.

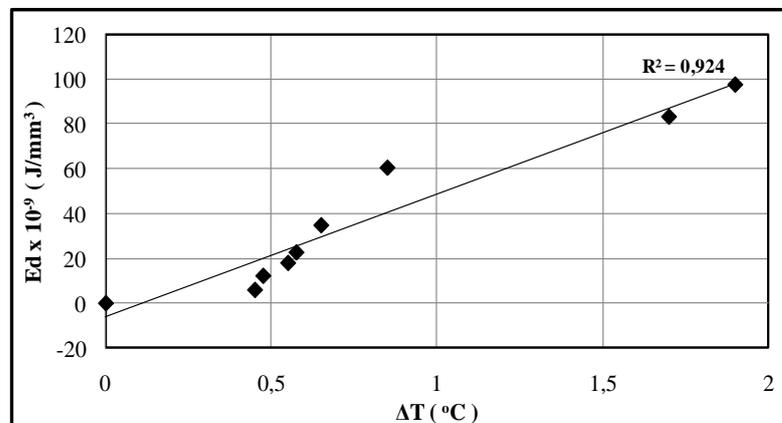
Figure 11. Energy dissipation versus ΔT_{stable} of GFRP composite for different load level.
